**NAVAL  
POSTGRADUATE  
SCHOOL**

**AN EXAMINATION OF MAN-MADE RADIO NOISE  
AT 37 HF RECEIVING SITES**

January 2005

8. PERFORMING ORGANIZATION REPORT NUMBER  
NPS-EC-05-003

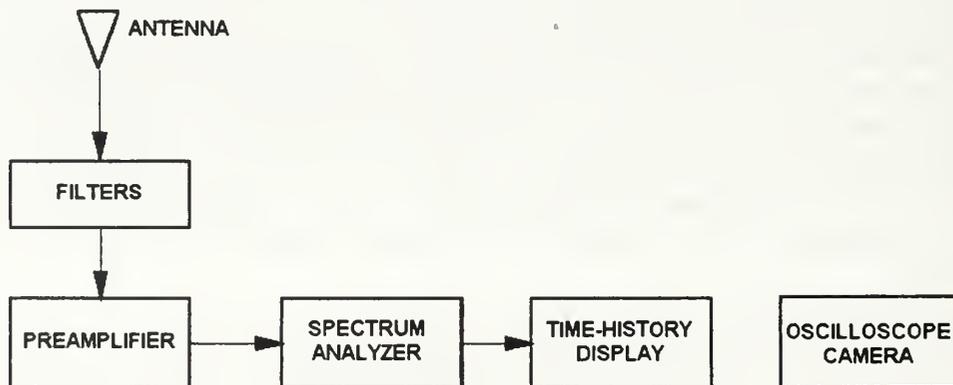
Figure 1 Block Diagram of the Instrumentation

Figure 1 shows a block diagram of the site measurement instrumentation. It consisted of a bank of band-pass filters, used one at a time, to limit the total signal and noise power into the preamplifier and the spectrum analyzer to low enough levels to avoid saturation and the deleterious effects of nonlinear operation. At later times it was necessary to replace the filters with a preselector to cope with the dense signal environment in the HF band. A high dynamic range preamplifier was used to obtain a signal- and noise-detection sensitivity about equal to that of a standard HF receiver. A spectrum analyzer (HP-141) was used as a scanning or fixed-tuned receiver to observe signals and noise within the pass band of each filter. This particular model of spectrum analyzer was chosen because of its short dead time between scans compared to more modern analyzers, and its ability to be quickly adjusted to cope with time-changing noise conditions. A time-history display (ELF Engineering Inc. Model 7200B) was used to portray a succession of 60 analyzer scans in a 3-axis format and provide the operator with a visual view of all signals and noise in the band under observation. An oscilloscope camera was used to photograph any desired time-history view.

The site instrumentation is described in detail in another publication, as is the source-location and source-identification instrumentation<sup>1</sup>. All examples of noise data collected at all sites were fully calibrated in frequency, amplitude, and time. Site and measurement system parameters are provided in a line under each item of data where each item is separated by a comma. The information in this line is:

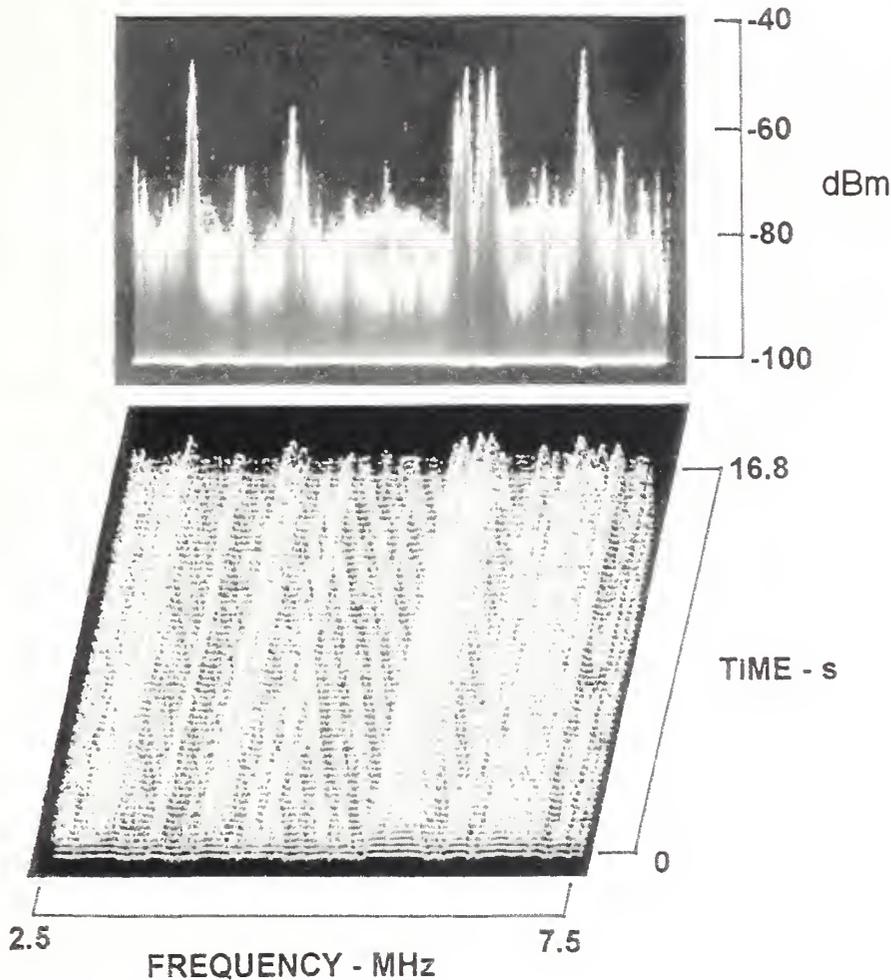
Figure 2 Coarse-Scale Example of Modest to Severe Power-Line Noise

Figure 2 shows a typical case of modest to severe radio noise from a source on a power line pole where the pole was about 2 km from the site. Two views of the same data are shown where the upper view is similar to the amplitude-vs-frequency presentation of a spectrum analyzer. The lower view shows 60 successive scans of the analyzer where amplitude is severely, but not completely, compressed. The slanting lines across the time-history view are caused by repetitive groups of impulsive noise interacting with the scan process of the spectrum analyzer. Strong signals exceed the noise and can be received without interference, but the weaker signals of high interest were covered up by the noise, and they could not be received.

HUM, Pasteup, 930518, 1435, 5, 5, 30, 200, H42, NF, 0, 0, -20

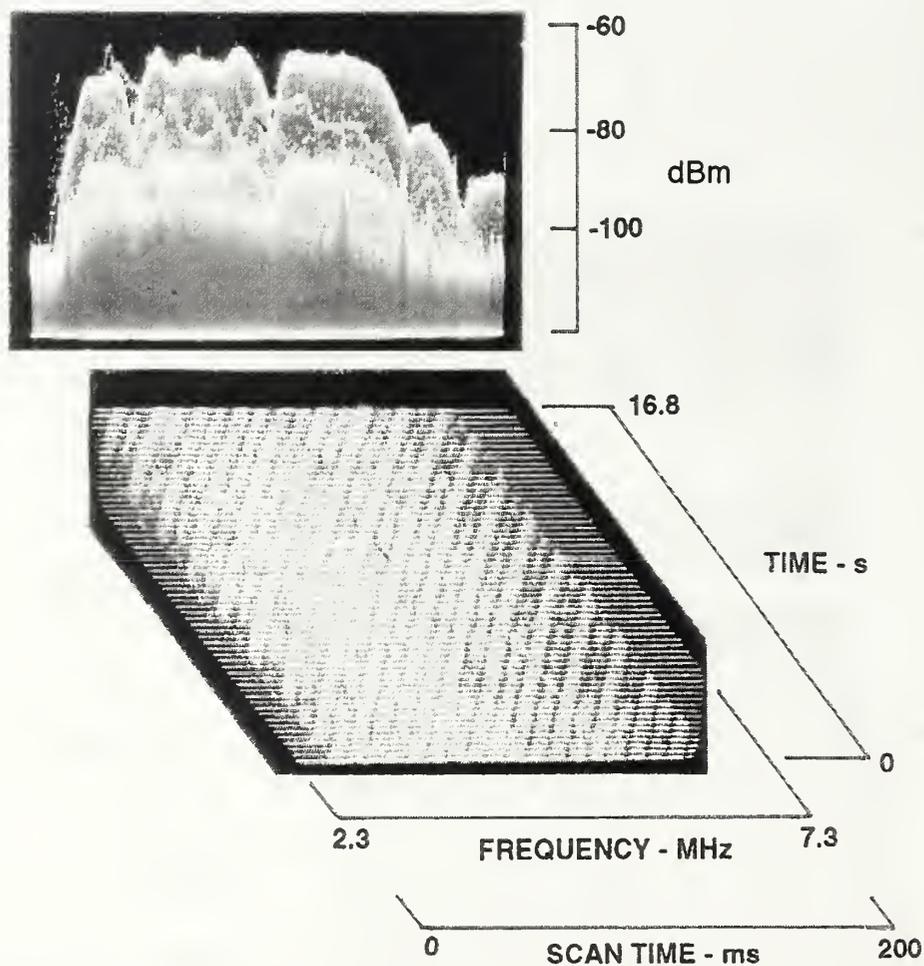
**Figure 3 Coarse-Scale Case of Severe Power-Line Noise**

Figure 3 shows an example of severe radio interference from a source on a power pole located 1 km from the receiving site. The noise covered up all signals over the frequency range of 2 to 8 MHz. The amplitude reduction of the noise at the low end of the frequency range is from a band-pass filter used to limit the total signal and noise power received by the instrumentation. Three sources of noise can be identified in the amplitude-vs-frequency view along with peaks and nulls in amplitude with frequency. The temporal structure shown in the time-history view indicates all sources are on the same phase of the power line.

HAN, 920402, 1118, 4.8, 5, 30, 200, A-192, F(2-8), a192, 20, -10, -20

The section of distribution line with the onerous sources causing the noise in Figure 3 was rebuilt according to the noise-free procedures in Reference 1. This completely eliminated these particular sources, and this section of distribution line remains free of noise today, more than a decade after the line overhaul.

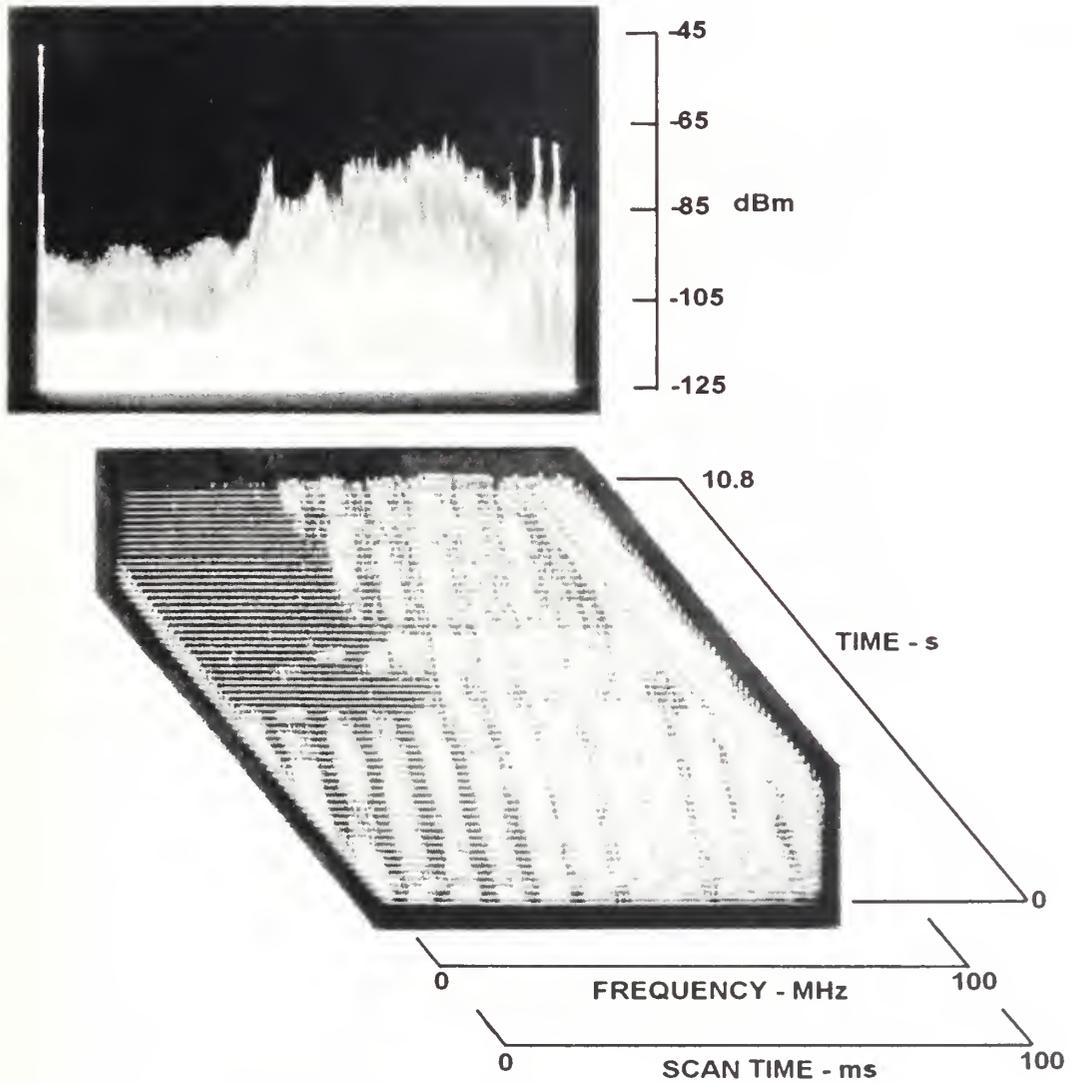
**Figure 4** Coarse-Scale Presentation of Intermittent Noise

The time-history view of Figure 4 shows the noise is from a source that is erratic in operation. This is typical of many sources of man-made noise, and the time-varying operation of such sources complicates the task of providing simple descriptions of such noise. In the bottom half of the time-history view the amplitude was fairly constant across the HF band, but it then increased in amplitude up to about 80 MHz. In addition narrow peaks and nulls in the amplitude of noise along the frequency axis made it impossible to provide a single value for noise amplitude for this case and other similar cases.

SARGENT, 860713, 1500, 50, 100, 300, 100, 1m, NF, 24, 0, -20

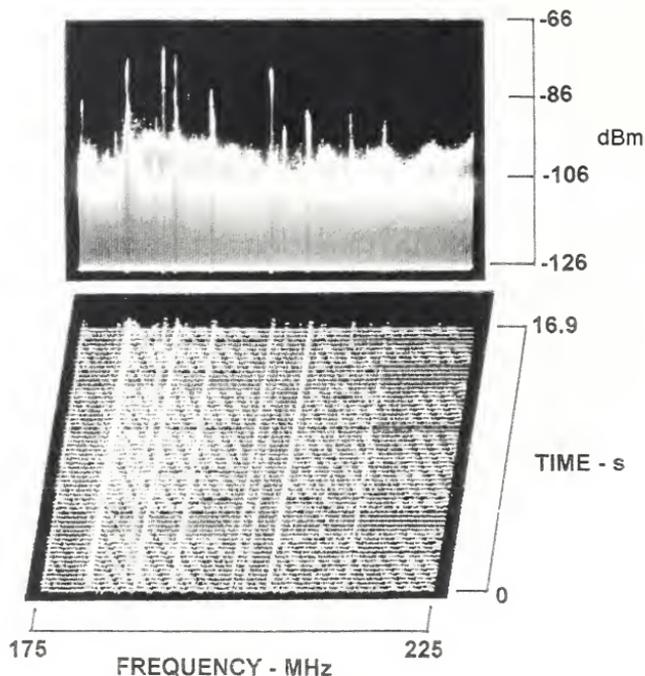
Figure 5 Intermittent Noise from a Source Close to a Receiving Site

Figure 5 shows another case of intermittent noise from a source on a power pole. In this case the noise extended from the low end of the HF band up into the VHF and UHF bands. The noise in the upper part of the VHF band is shown in the example. The intermittent activity of the source resulted from the slight movement of the pole hardware from wind. This source was active only on clear days with low humidity. Source activity stopped in the late afternoon when humidity increased slightly and remained off during most of the nighttime, resuming again in the mid-morning hours. The source was inactive during rain and fog while other sources within line of sight became active as humidity increased.

In this example, the source was on a distribution line pole feeding power to the site, and the pole was located only about 100 m from the receiving antenna.

D-L, Pasteup, 940921, 1418, 200, 50, 30, 200, A3-V, NF, 16, 0, -30

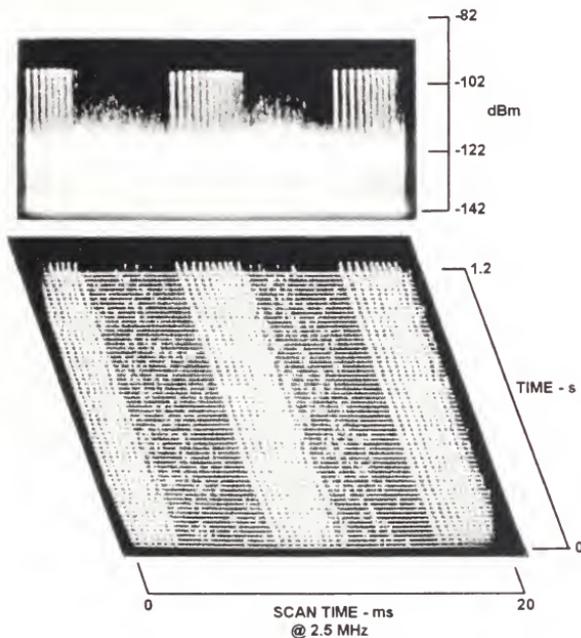
Figure 6 Fine-Scale Temporal Structure of Power-Line Noise, Example 1

Figure 6 shows an example of the fine-scale temporal structure of noise emanating from a frequently observed type of source. In this case the frequency-scanning process was set at zero with the spectrum analyzer frequency control set to 2.5 MHz. The scan process of the analyzer was synchronized to the frequency of the power source for this example. With these settings the output data is similar to the presentation on an oscilloscope operating in its line-sync mode. The noise consists of groups of close-spaced impulses which occur every 8.3 ms, one half the period of the power-line frequency. The uniform amplitude of each impulse is shown in the upper view, and the distinctive temporal pattern of the impulses in each group is shown in the lower view. The unique temporal pattern of this example identifies the most likely source of the noise as a bell insulator on a nearby overhead distribution line. The signatures of this and many other sources of noise are illustrated and described in Reference 1.

NPS BEACH, 931123, 1033, 2.5, 0, 10, 20LS, 3m, F(2-8), 22, 0, -40
